# New York State Department of Transportation

## Yellow Flag NB2258W003

**BIN: 1065318**

Location: Span 67, Girder G12 at Pier 66 over 3rd Avenue Eastbound.

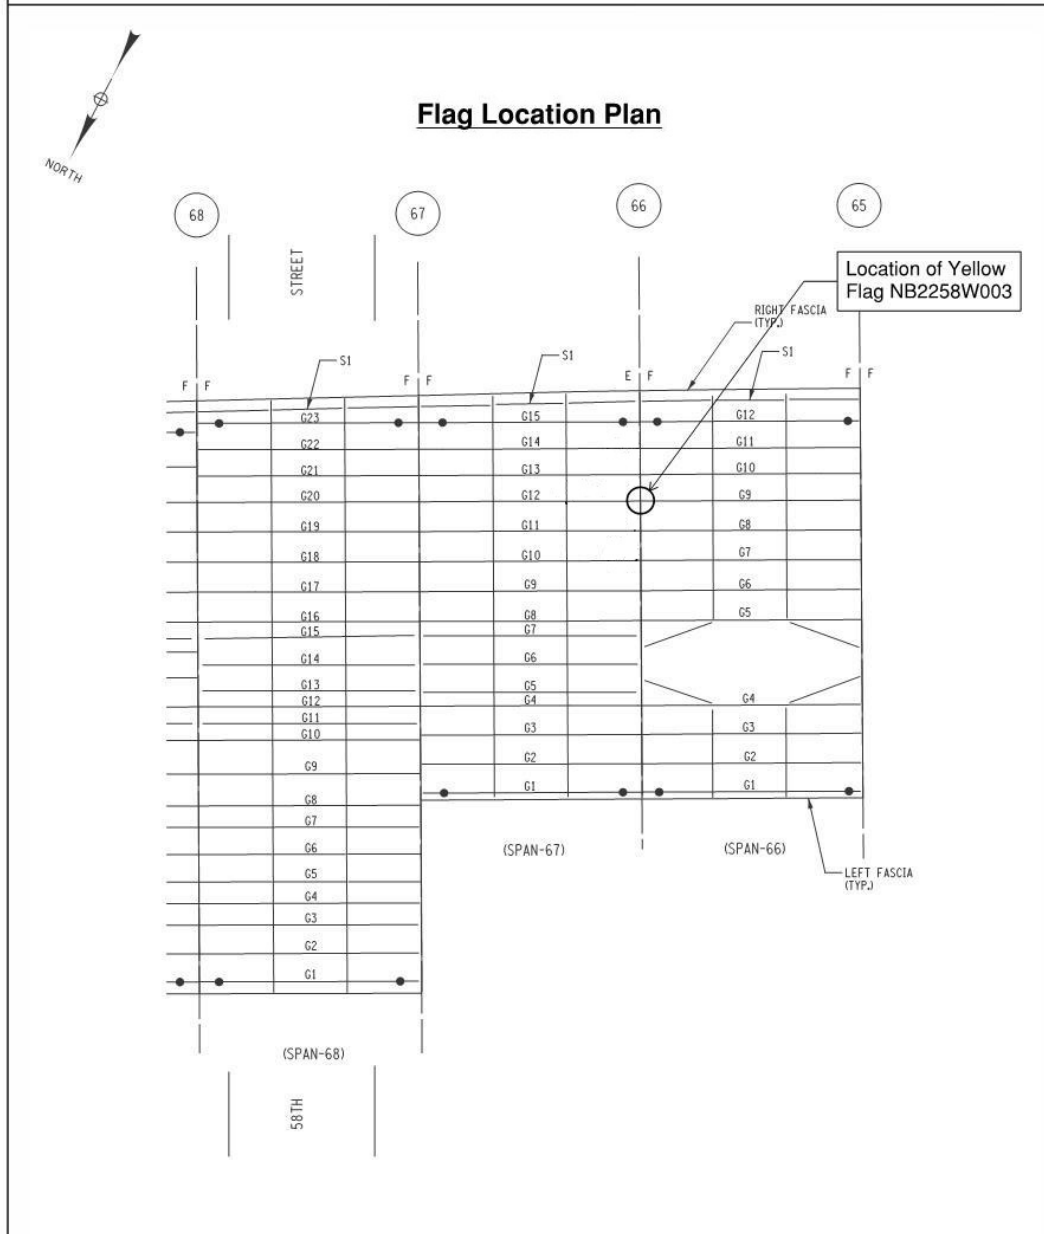
**Flag Photographs**Photo Number: **1**Photo Filename: **22\_Flag Location Plan.jpg**Gowanus Expressway  
2022 Biennial Inspection - Field SketchBIN: 1065318Team: AA/TSDate: 06/21/2022Span: 67Location: Girder G12 at Pier 66

**Attachment Description: Flag Location Plan**

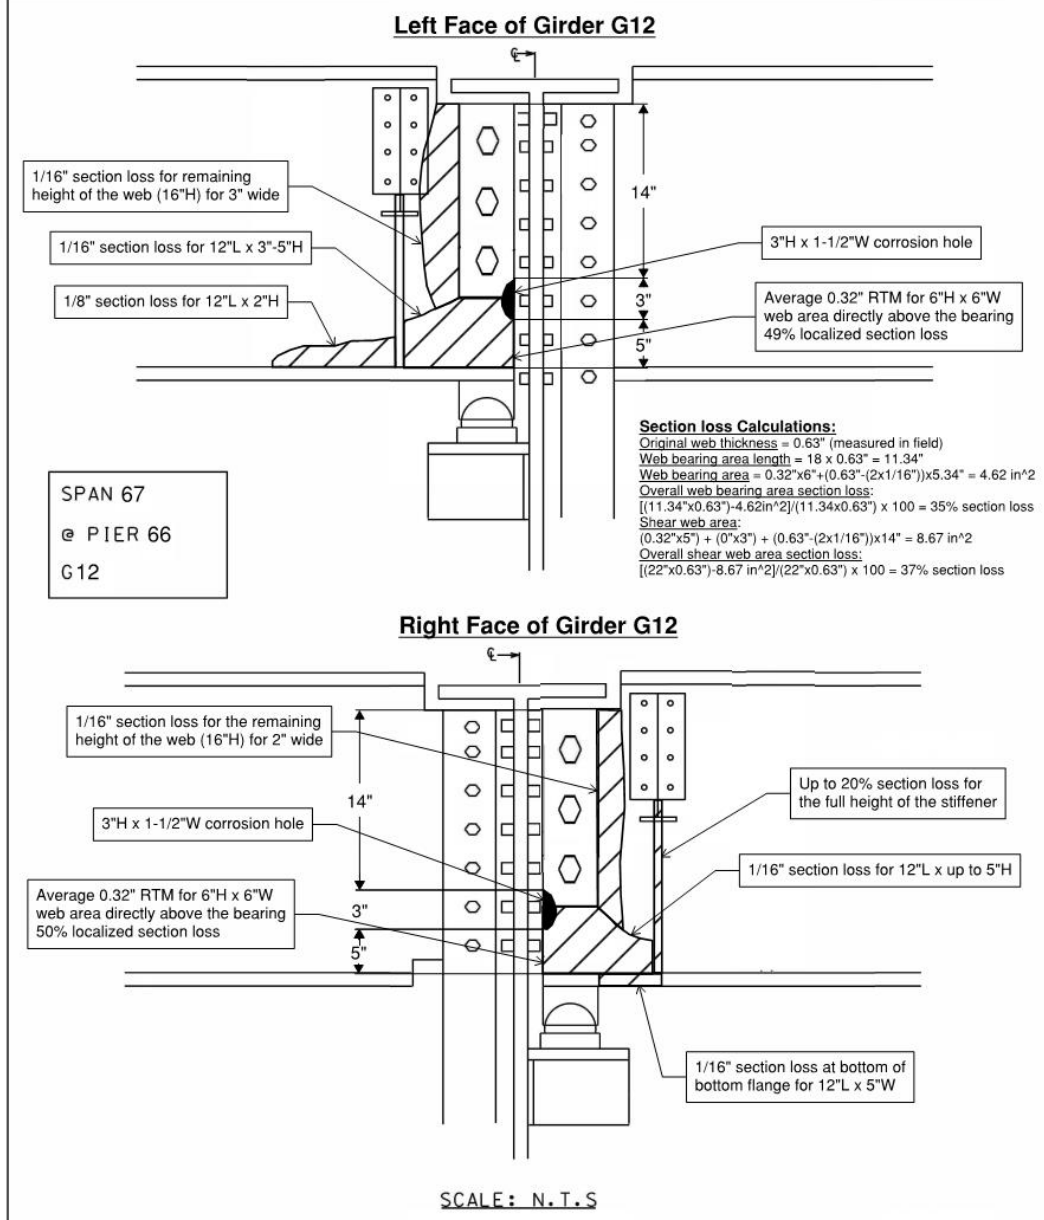
Photo Number: 2

The overall section loss for the web bearing area is approximately 35% and shear web area is approximately 37%. Refer to Yellow Flag Condition Sketch (Photo 2) for more details.

Attachment Description: Yellow Flag Condition Sketch

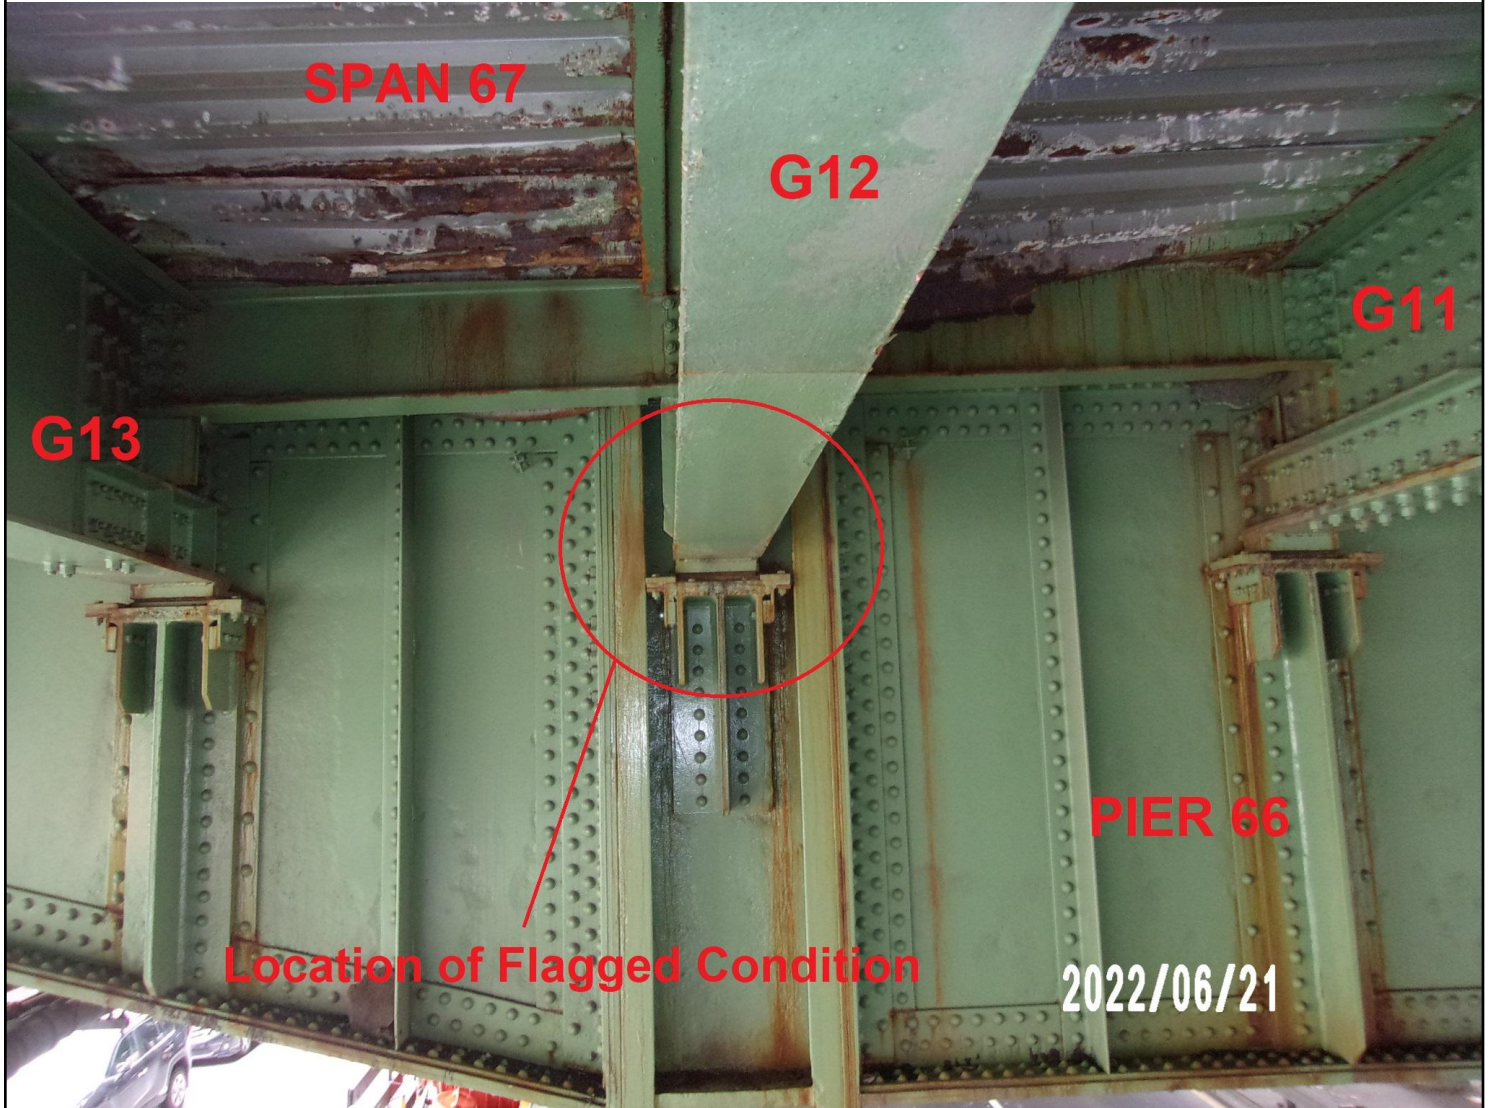
Photo Number: 3

**Attachment Description:** General view of the flagged location at Girder G12 in Span 67 at Pier 66. Looking Begin.

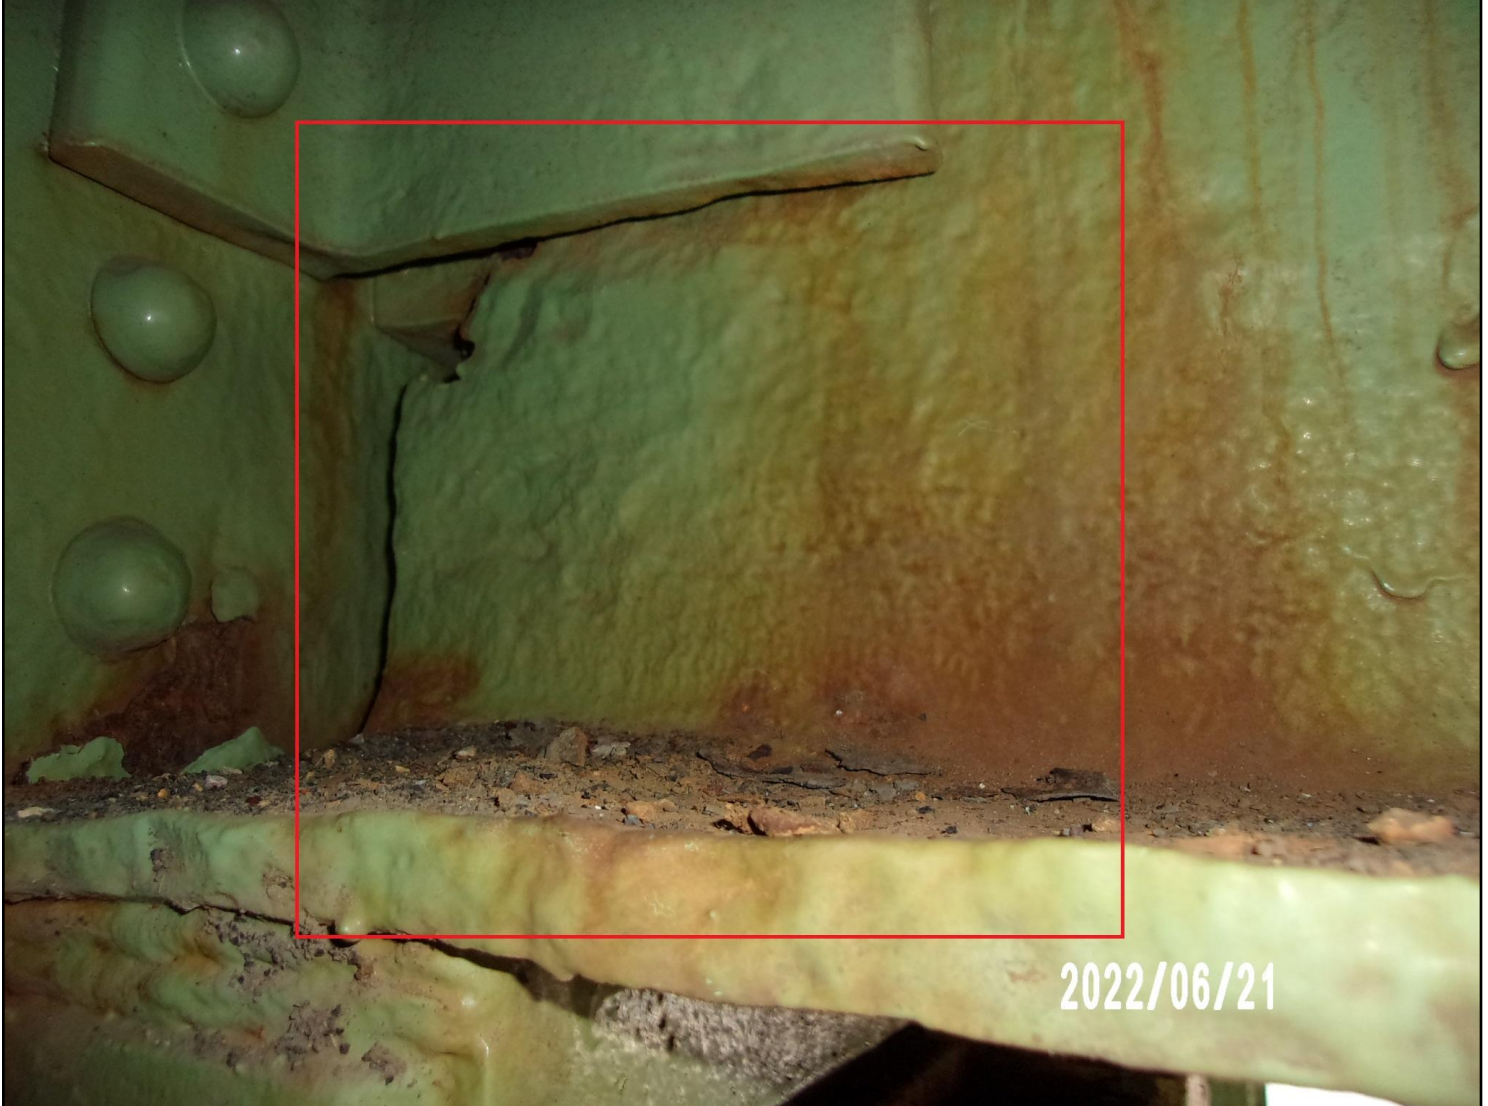
Photo Number: 4

Description: The end of Girder G12 on Span 67 side of Pier 66 exhibits section loss for 6" H x 6" W area in the girder web directly above the bearing with average 0.32" remaining thickness measured (RTM) within area resulting in approximately 49% localized section loss (Photos 4 and 7).

**Attachment Description:** The right face of Girder G12 in Span 67 at Pier 66. The lower web of the girder exhibits approximately 49% section loss for 6" H x 6" W area in the girder web directly above the bearing. Looking Left.

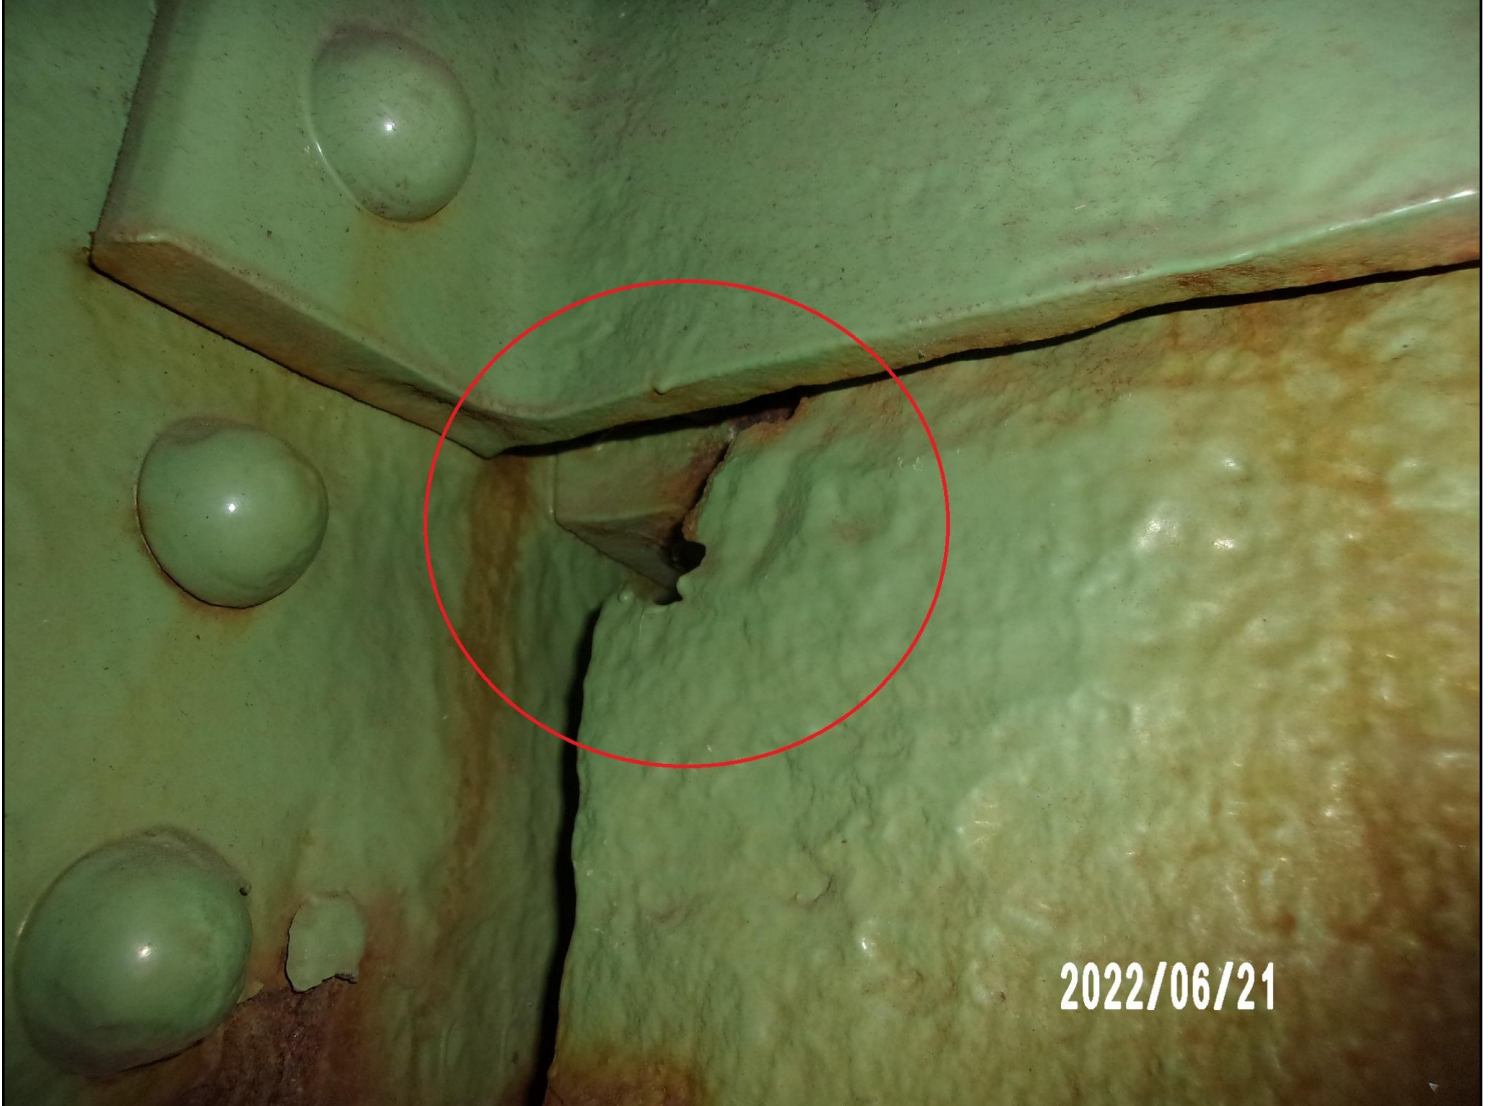
Photo Number: 5

The end of the girder web, approximately 5" high from the bottom flange above the bearing exhibits 3" H x 1-1/2" W corrosion hole in the web (Photo 5). The lower web of the girder on the end side of the bearing exhibits section loss above the bottom flange for 1/16" deep for 12" L x 3"-5" H followed by 1/8" deep for 12" L x 2" H at the left face and 1/16" deep for 12" L x up to 5" H at the right face (Photo 8). The remaining web height along the guide angles (approximately 16" H area) exhibits 1/16" deep section loss for 3" wide at the left face and 2" wide at the right face (Photos 6 and 9).

**Attachment Description:** The right face of Girder G12 in Span 67 at Pier 66. The end of the girder web approximately 5" high from the bottom flange above the bearing exhibits 3" H x 1-1/2" W corrosion hole in the web. Looking Left.

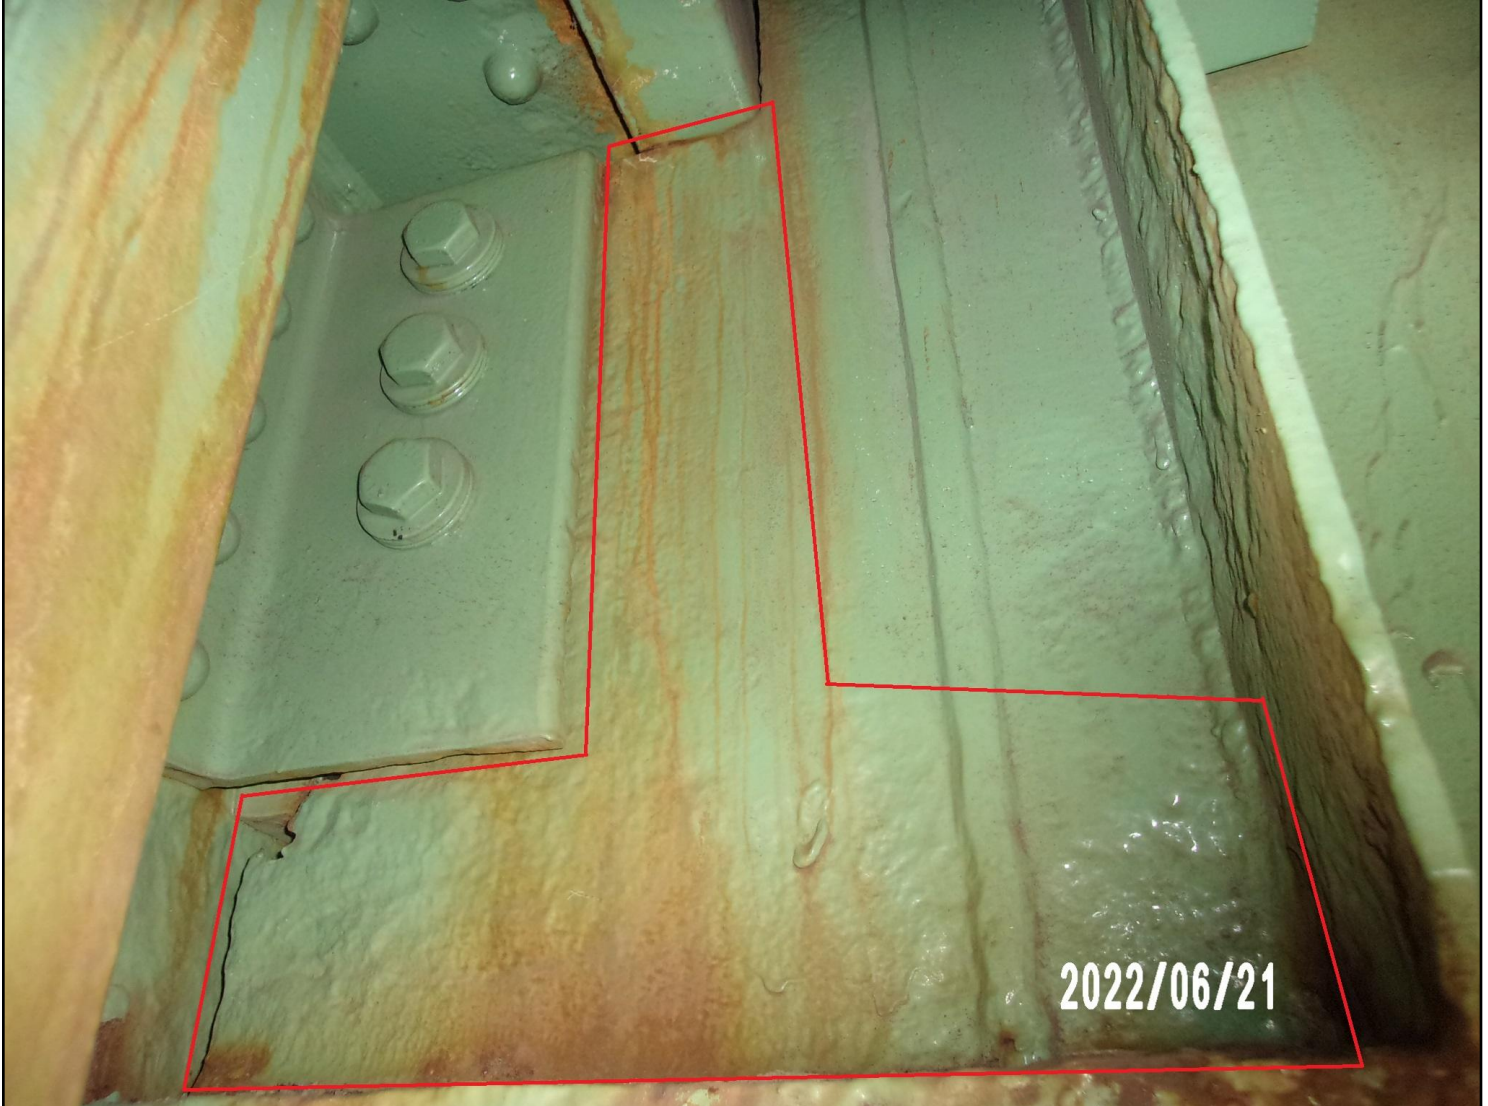
Photo Number: 6

**Attachment Description:** The right face of Girder G12 in Span 67 at Pier 66. The girder web exhibits 1/16" section loss for the remaining web height along the guide angle and in the lower web above the bottom flange in front of the bearing. Looking Left.

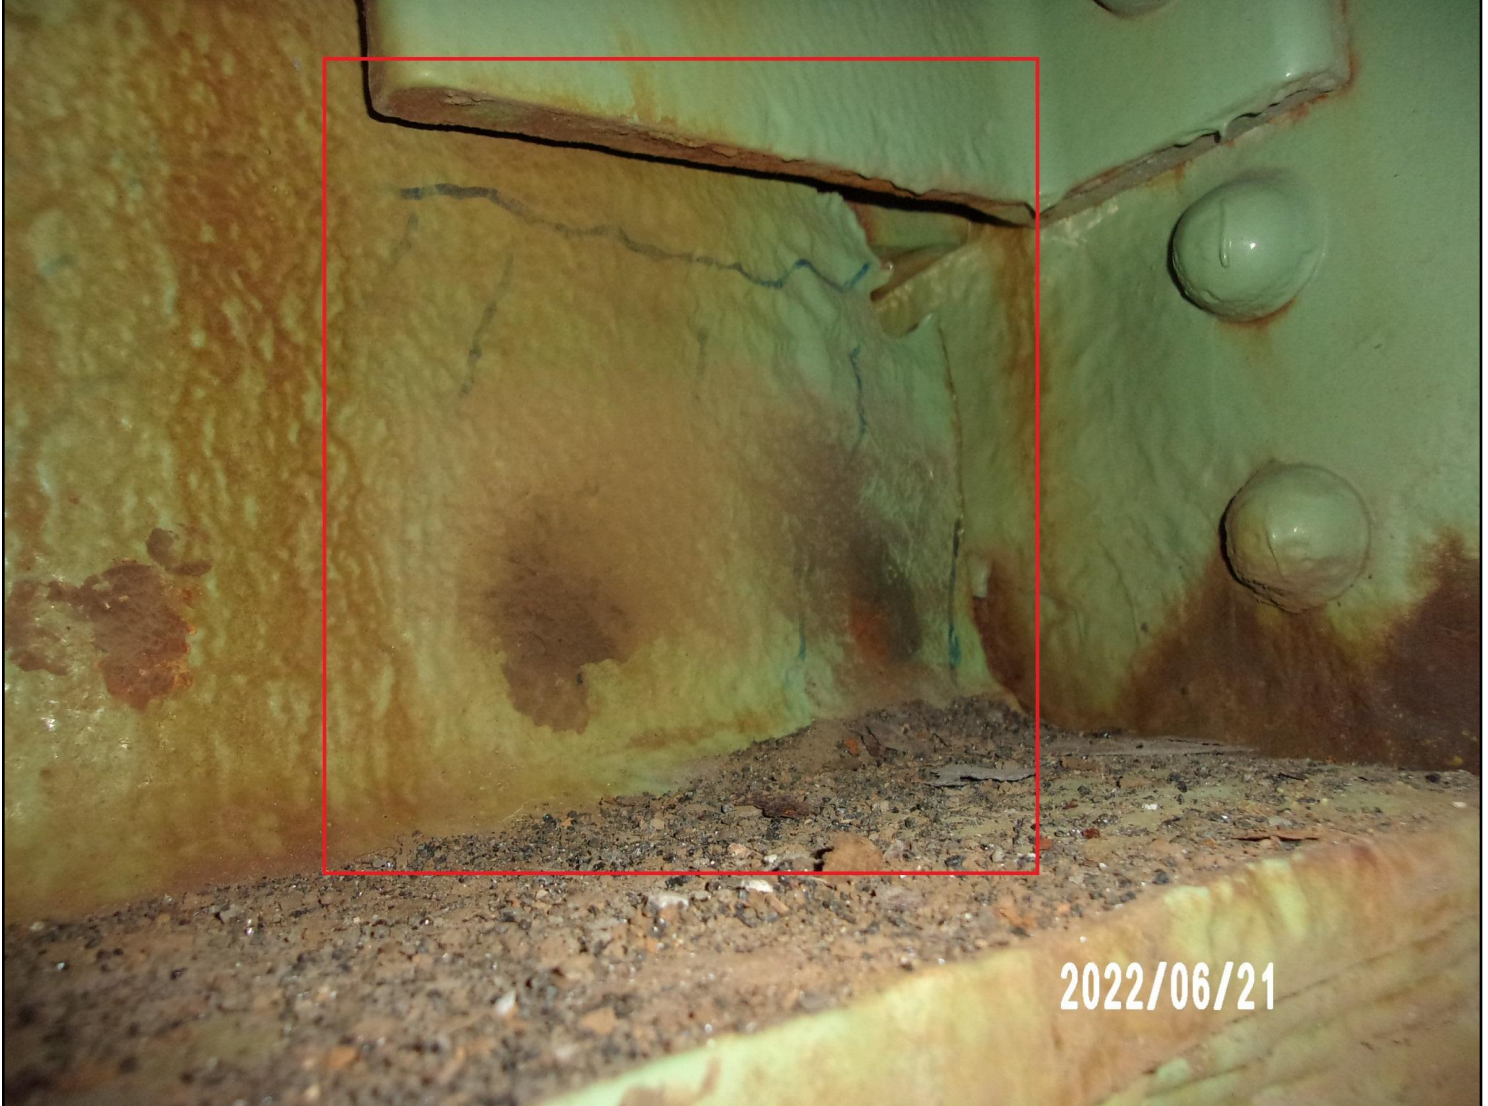
Photo Number: 7

**Attachment Description:** The left face of Girder G12 in Span 67 at Pier 66. The lower web of the girder exhibits approximately 49% section loss for 6" H x 6" W area in the girder web directly above the bearing. Looking Right.

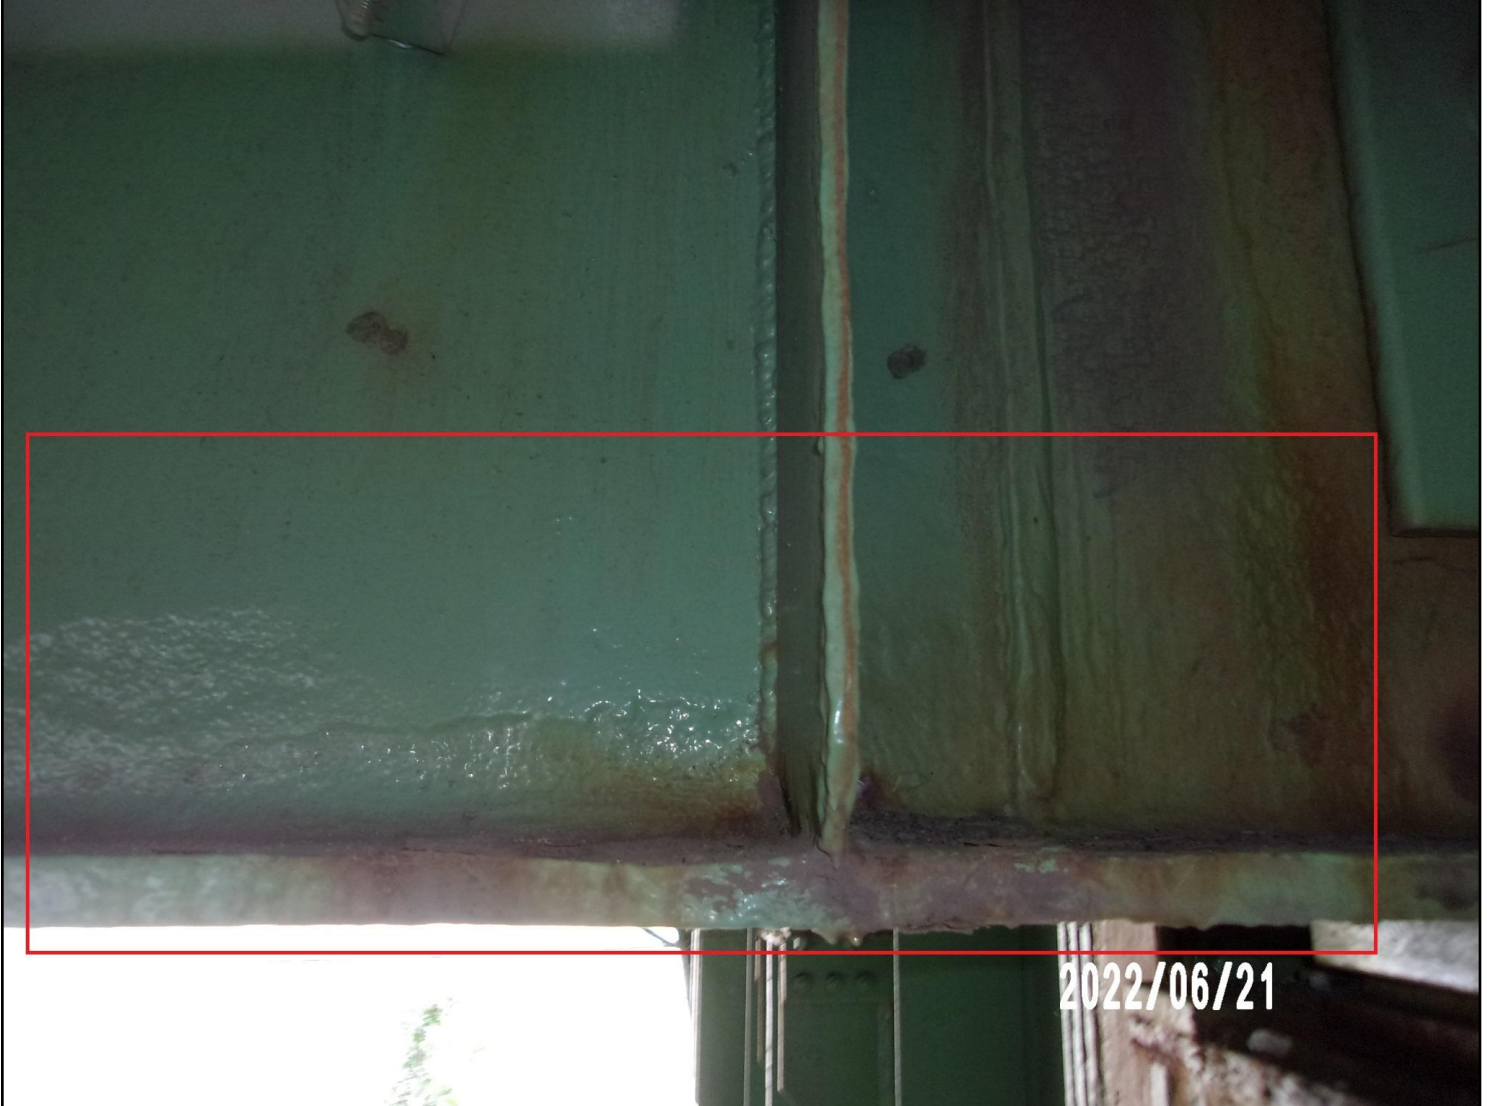
Photo Number: 8

**Attachment Description:** The left face of Girder G12 in Span 67 at Pier 66. The lower web of the girder in front of the bearing exhibits section loss above the bottom flange for 1/16" deep for 12" L x 3"-5" H followed by 1/8" deep section loss for 12"L x 2"H. Looking Right.

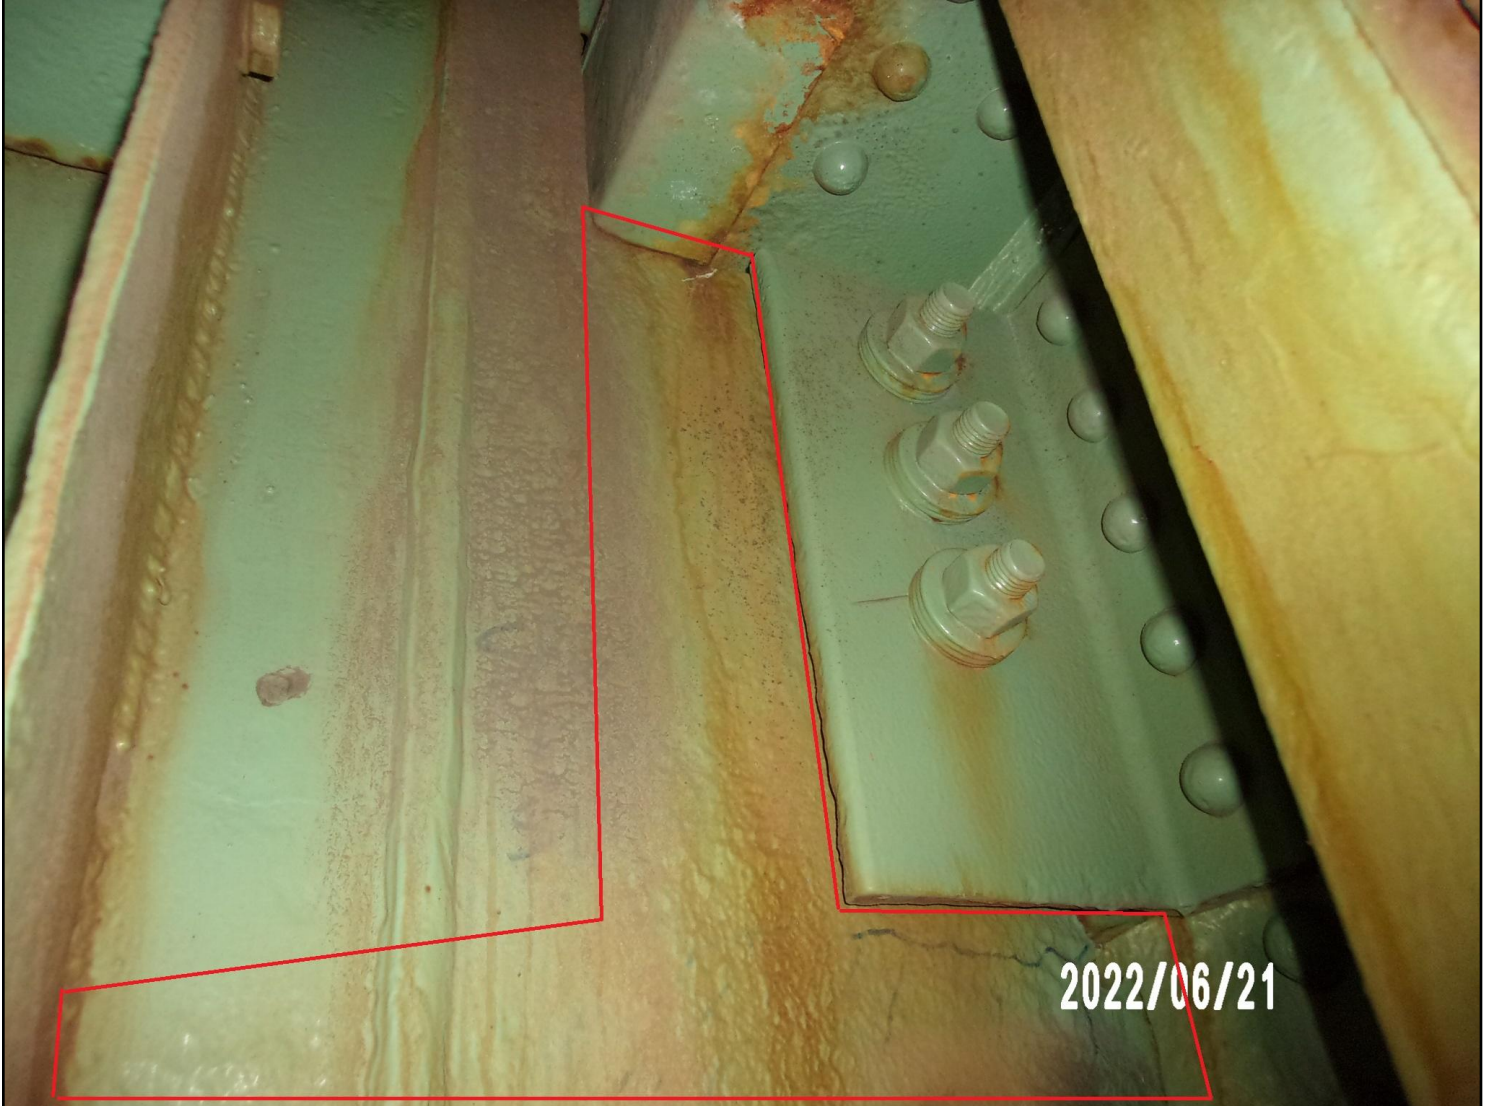
Photo Number: 9

**Attachment Description:** The left face of Girder G12 in Span 67 at Pier 66. The girder web exhibits 1/16" section loss for the remaining web height along the guide angle and in the lower web above the bottom flange in front of the bearing. Looking Right.
